# MSFC Safety *Bulletins*

## Monorail Hoist Close Call

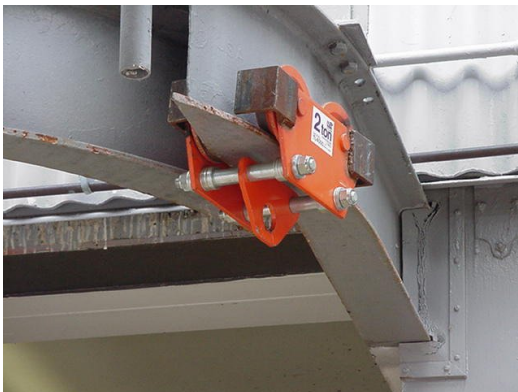
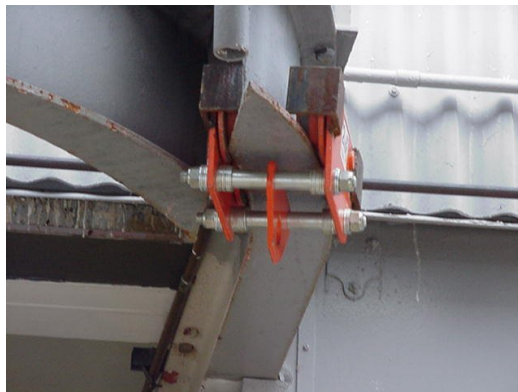
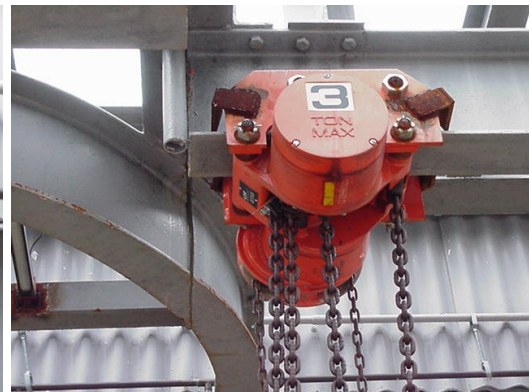
The monorail system had originally been installed at Marshall during the 1960's with a 3-ton hoist. This particular monorail had a section of movable rail that was able to switch between a rail system inside the room to a rail system outside the room. There was a stop installed on the monorail to stop the 3-ton hoist if the movable rail section was moved. The 2-ton hoist was installed at a later date and was physically smaller than the larger hoist. It was unknown that the 2-ton hoist could move past the stop on the rail.

As the piece of equipment was being lifted, the hoist centered itself above the load. The 2-ton hoist then moved past the stop and fell from the monorail. Fortunately, there were no personal injuries and no reportable property damage.

These pictures only show the trolley - the hoist has been removed.

1. Procurement of all stationary lifting equipment must comply with the design/hardware requirements contained in NSS/GO 1740.9, "Safety Standards for Lifting Devices and Equipment", as required by Marshall Work Instruction MWI 6430.1, "Lifting Equipment and Operations".
2. The coordination of this function is the responsibility of the Facilities Engineering Department.
3. The Facilities Engineering Department must approve procurement or modifications of all stationary lifting equipment.
4. MWI 5100.1A, "Procurement Initiators Guide" requires compliance with MWI 6430.1, "Lifting Equipment and Operations".
